Plainwell No. 2 Dam Area Time-Critical Removal Action Weekly Construction Update

Progress Report #5—September 14, 2009

Work Completed: September 3 – September 9, 2009

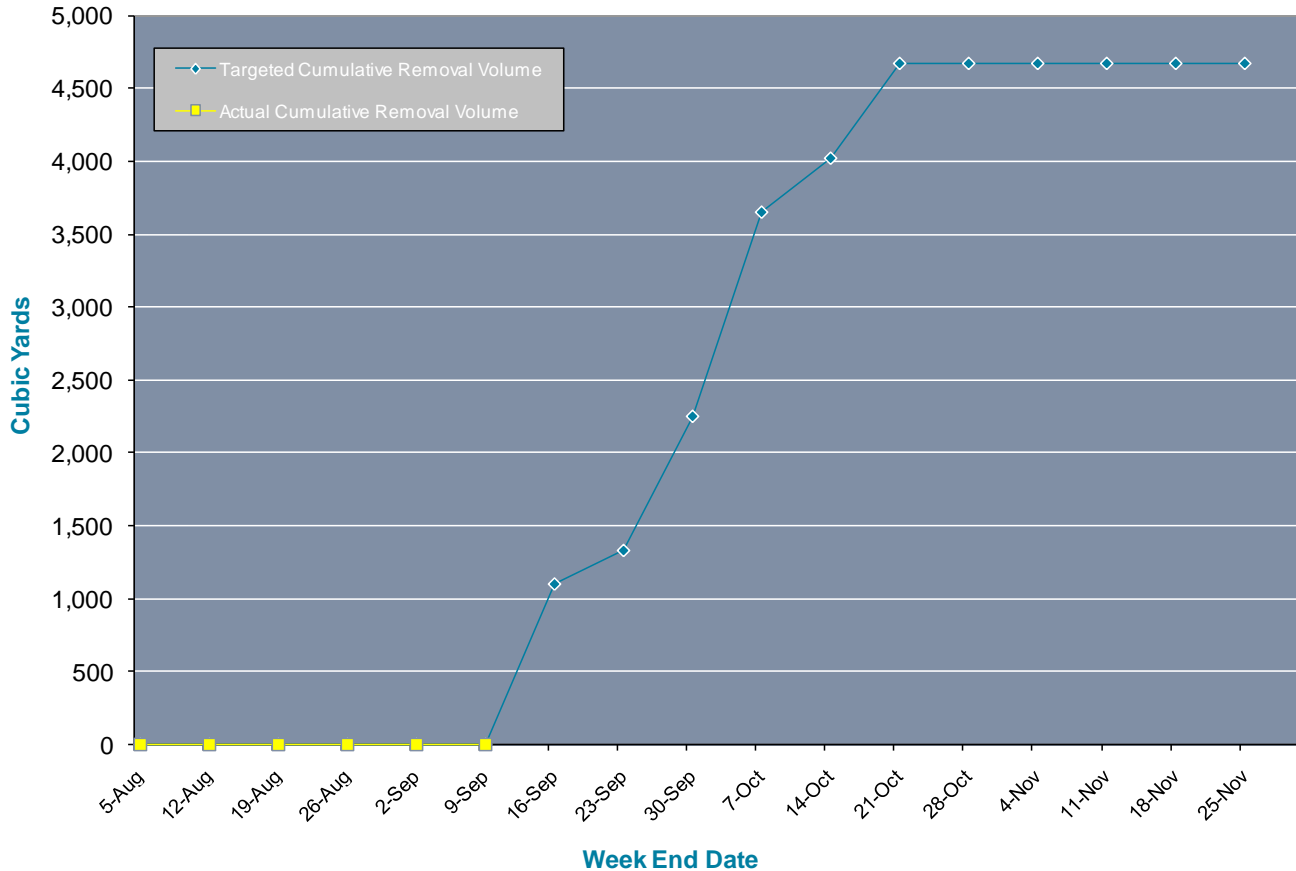
Removal Progress – 2009

Targeted volumes are neat and subject to change due to additional excavation done at request of USEPA.

Actual volumes removed below the targeted volumes potentially due to the conservative estimation methodology used to develop targeted figures and due to the actual topographic conditions encountered at the site, which could result in smaller volumes needing to be removed than originally estimated. The targeted volumes have been increased by 10% to account for additional material that could be removed as a result of over-excavation and additional removal in response to confirmation sampling.

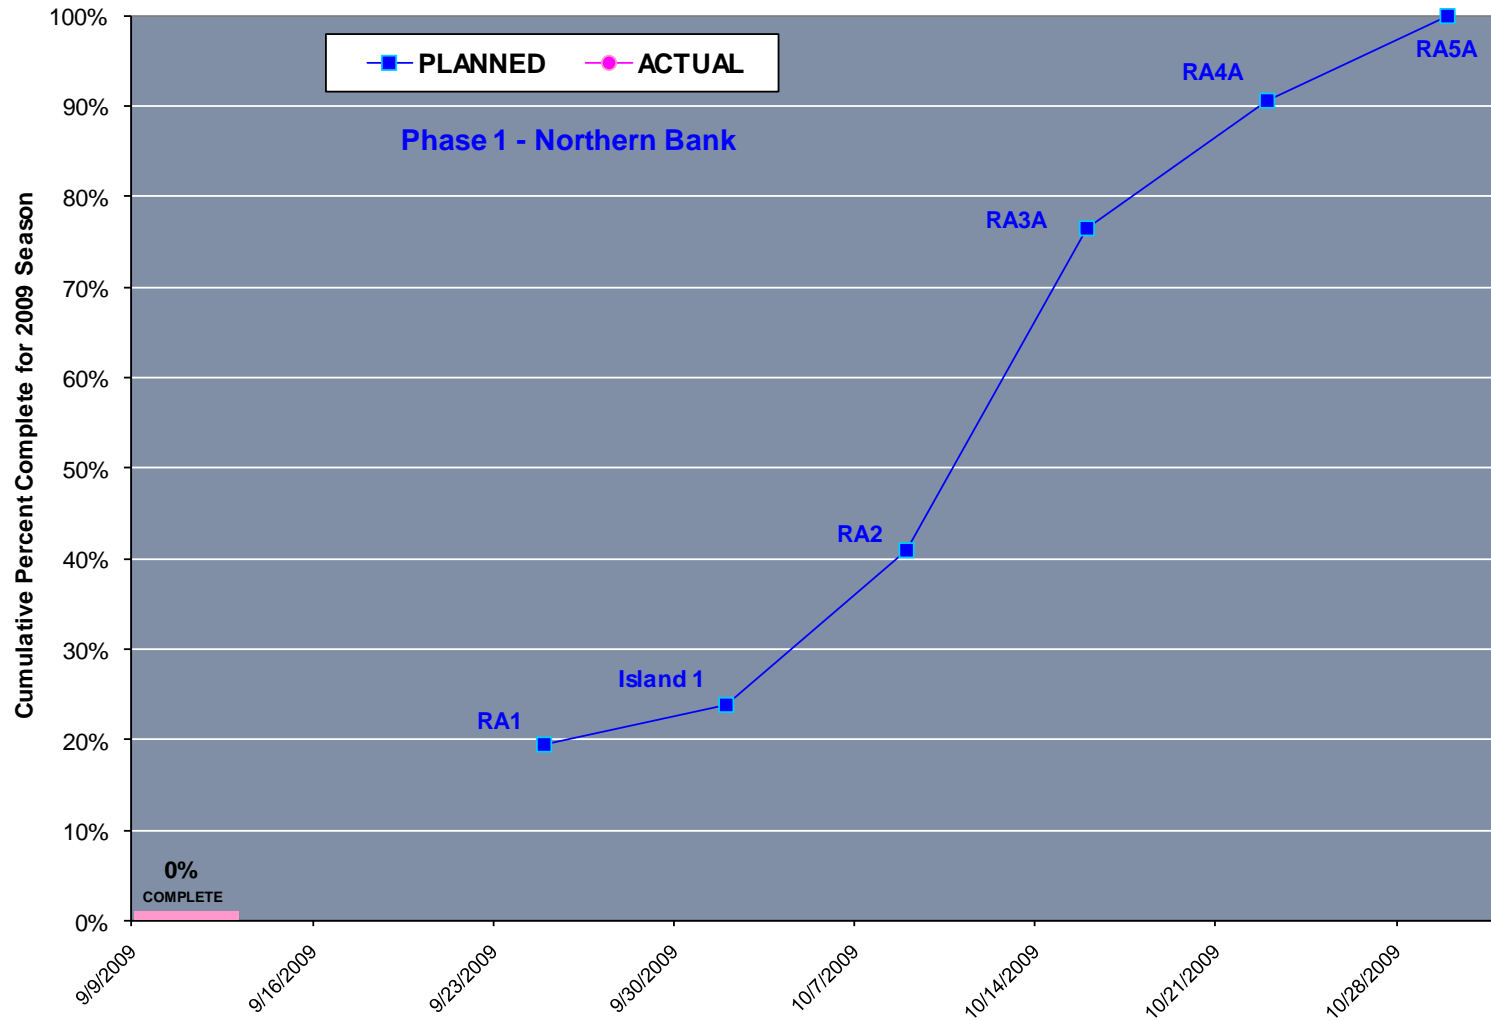
Removal Progress – 2009

For Areas where removal is less than 100% complete, the data point shown is an estimate based on area and volume considerations.

'Complete' is defined as removal of all targeted materials as detailed in the Plainwell No. 2 Dam Area Design Report.

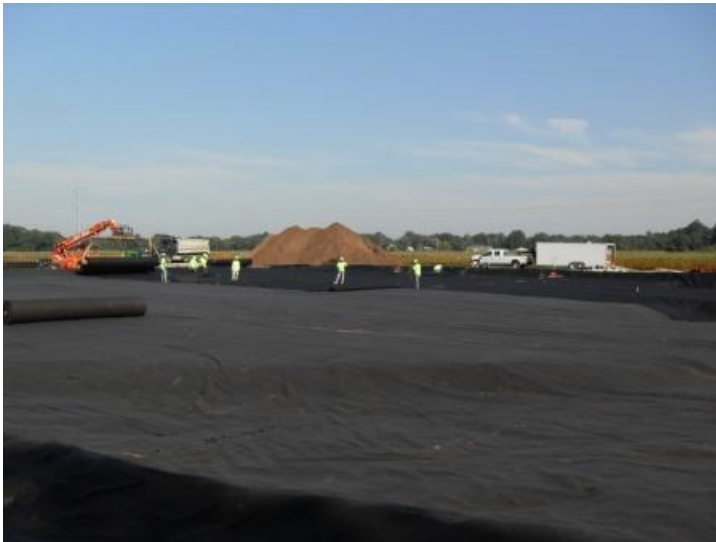
Installing geosynthetics at Staging Area 3.

- Began and completed the installation of a triple layer of geosynthetics across the footprint of Staging Area 3. Layers include a 40-mil HDPE flexible membrane liner between two layers of protective non-woven geotextile. Geosynthetics were installed by American Environmental Group Ltd.

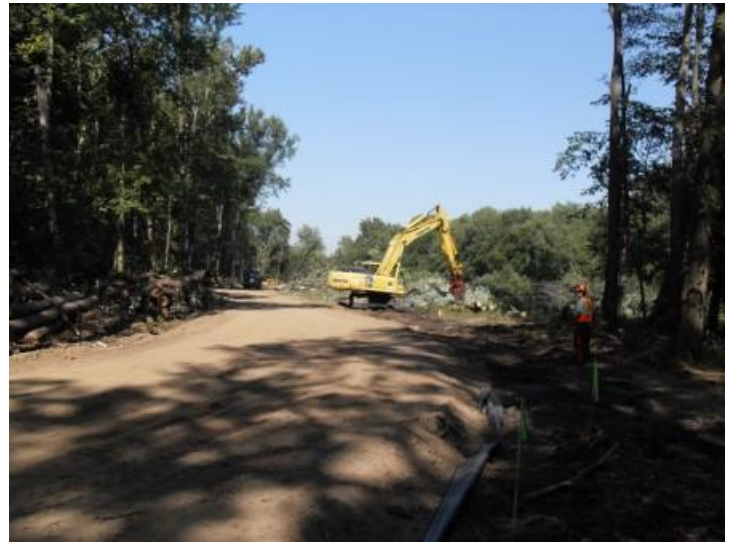
Clearing activities near Removal Area 2A.

- Continued clearing and grubbing activities in Removal Areas 1 through 5A.
- No activities were completed Monday, September 7th in observance of the Labor Day holiday.

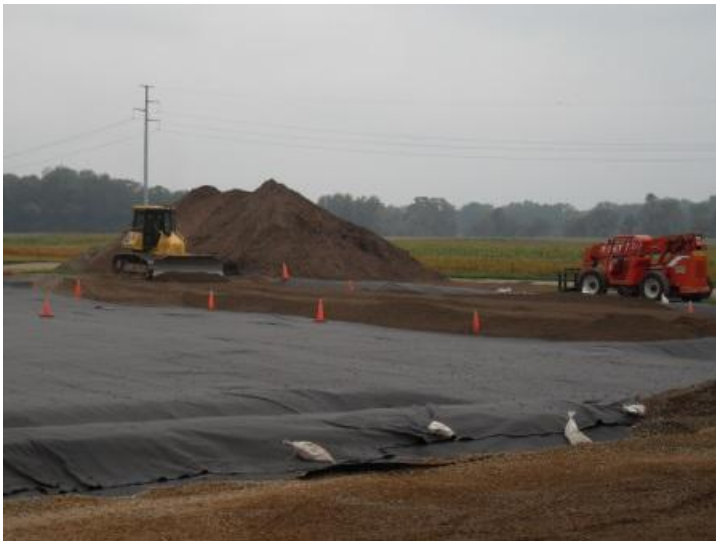
Installing a protective layer of aggregate material
at Staging Area 3.

- Continued constructing Staging Area 3 by installing 21AA and 6A aggregate on top of the installed geosynthetic layers.
- Continued constructing a haul road to access Removal Areas 1 through 5A. Aggregate for the construction of this haul road is being reused from existing haul roads developed for the former Plainwell Impoundment TCRA project.

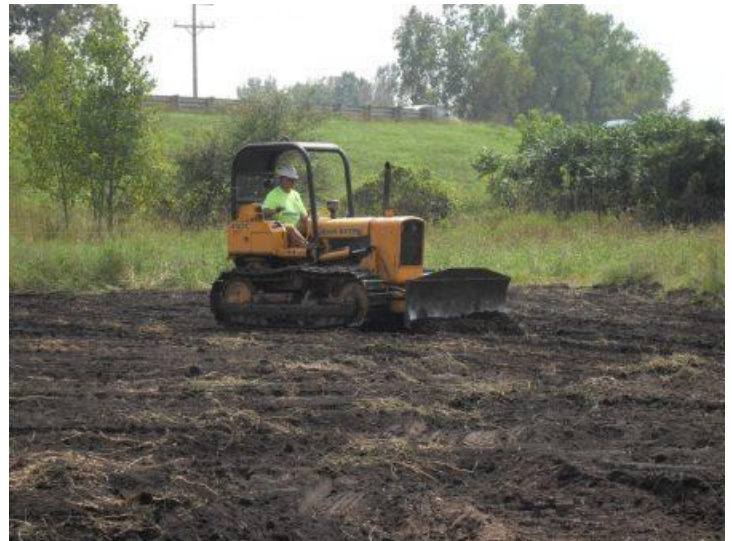
Installing topsoil in the former Plainwell
Impoundment TCRA project area after aggregate
removal and reuse.

- After removal of aggregate, completed installing and grading topsoil in the beds of former haul roads located in the former Plainwell Impoundment TCRA project area.
